Western Australia's Mining Rehabilitation Fund and Abandoned Mines Program

Sarah Bellamy and Paul West
Department of Mines and Petroleum

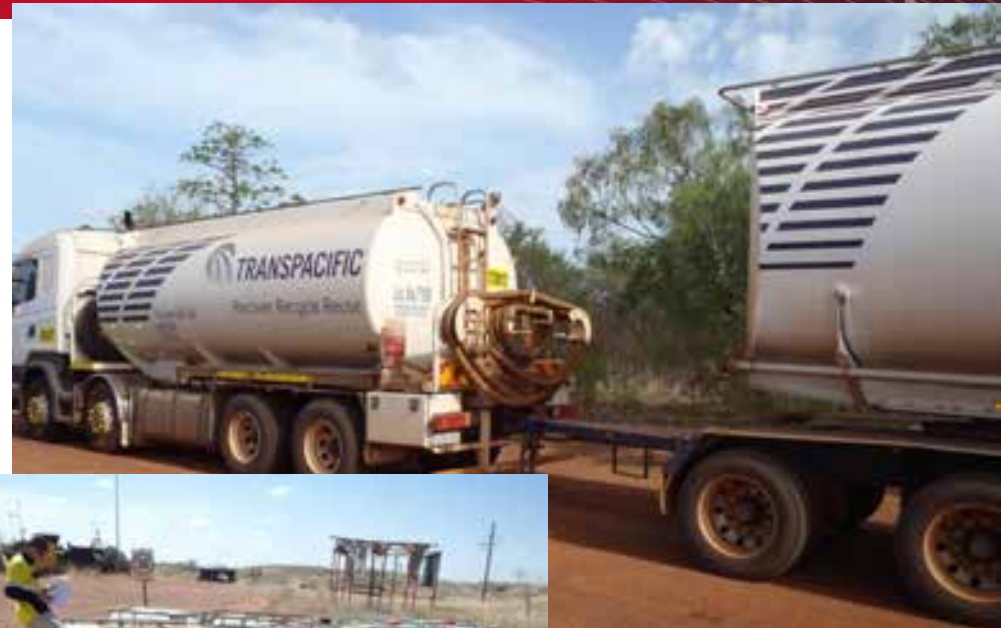
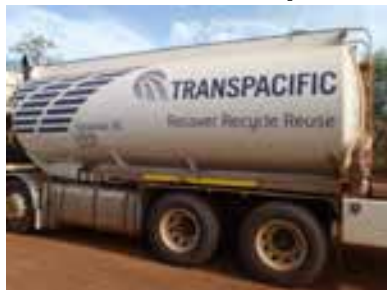
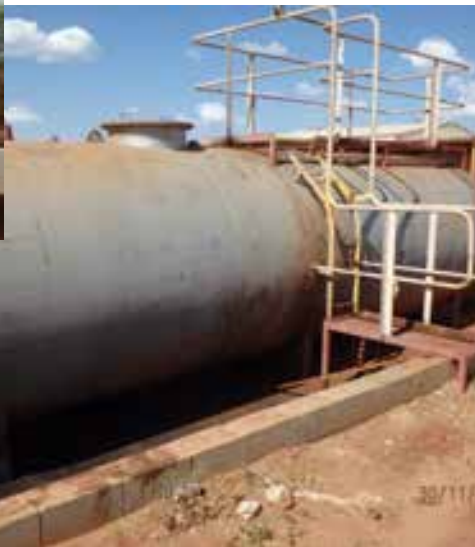
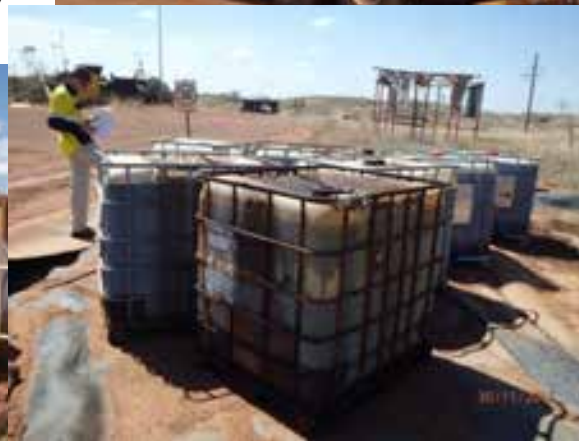
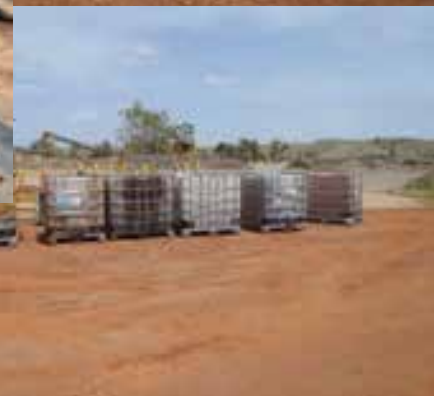
Ellendale - Hydrocarbon Removal

Removal of approximately:

- 20,000L of waste oil
- 3,500L of oily water and
- 1,500L of coolant
- 1,000L of cooking oil

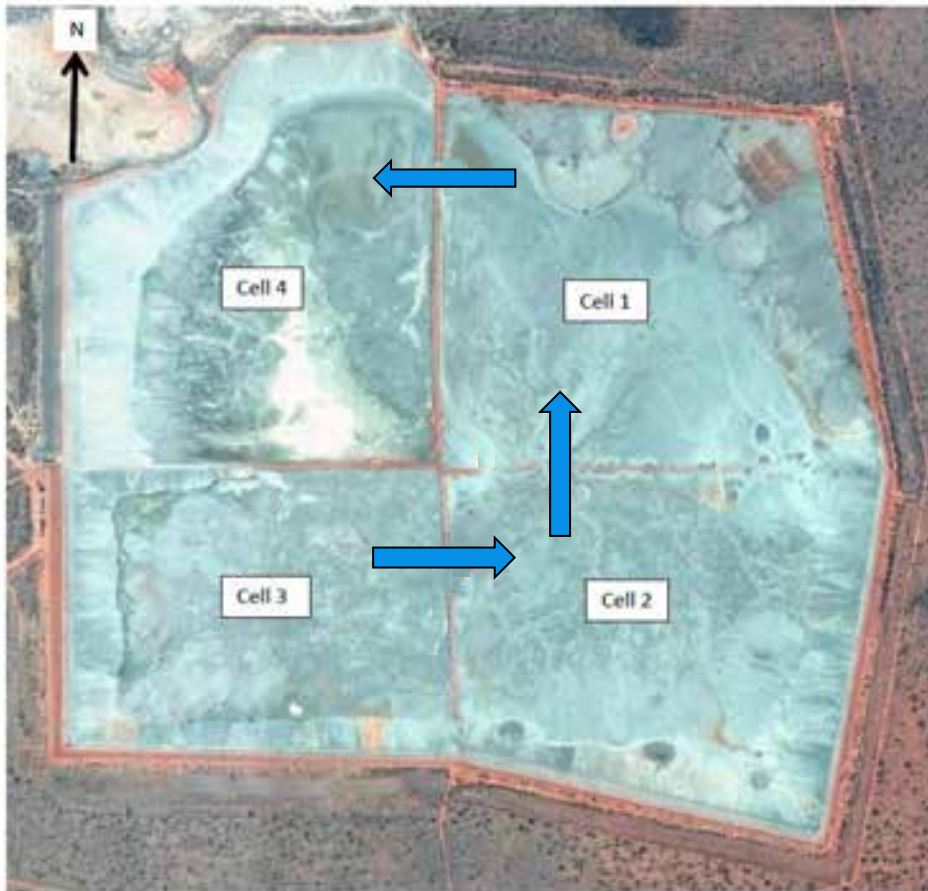
Figure 1 Aerial view of Ellendale TSF 1D

- Total Area = 222ha
- Active tailings surface = 202ha
- 2 lifts:
 - 1st lift – 5-10m, Pindan Sands
 - 2nd lift – 1-3m, Tailings

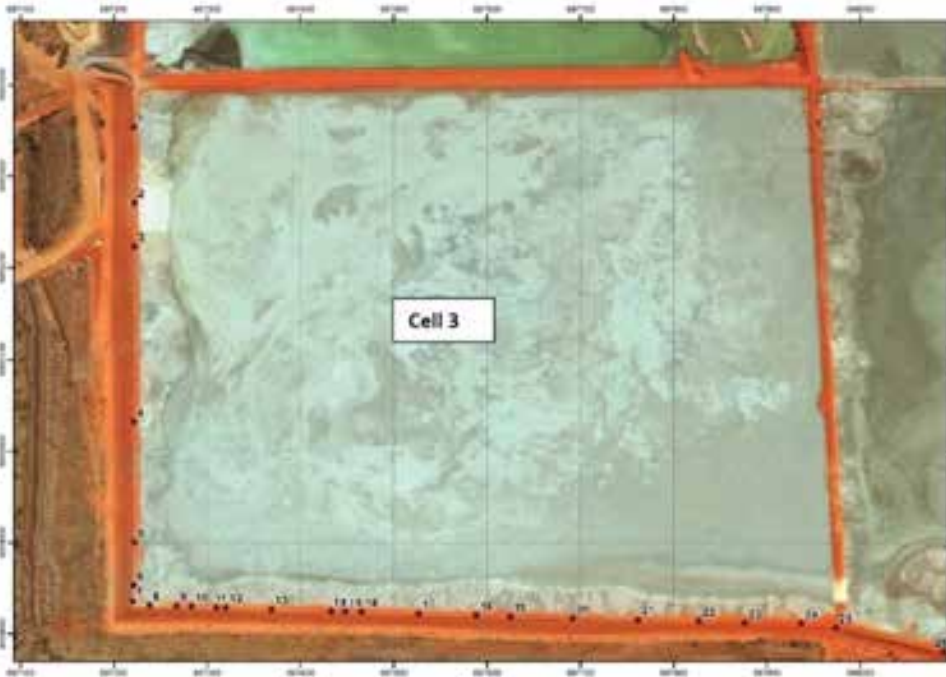
TSF Works – Rock Beds

Rock beds installed in problematic areas to reduce ponding

Controlled, slow infiltration limits tunnelling

B. Incorporation of rock beds into existing berm surface

Competent waste rock ripped into existing berm surface
ripping depth Maximum 200mm

Only rip to 100mm depth into existing berm surface from 1.2m distance

Commence ripping 3m from edge of rock layer

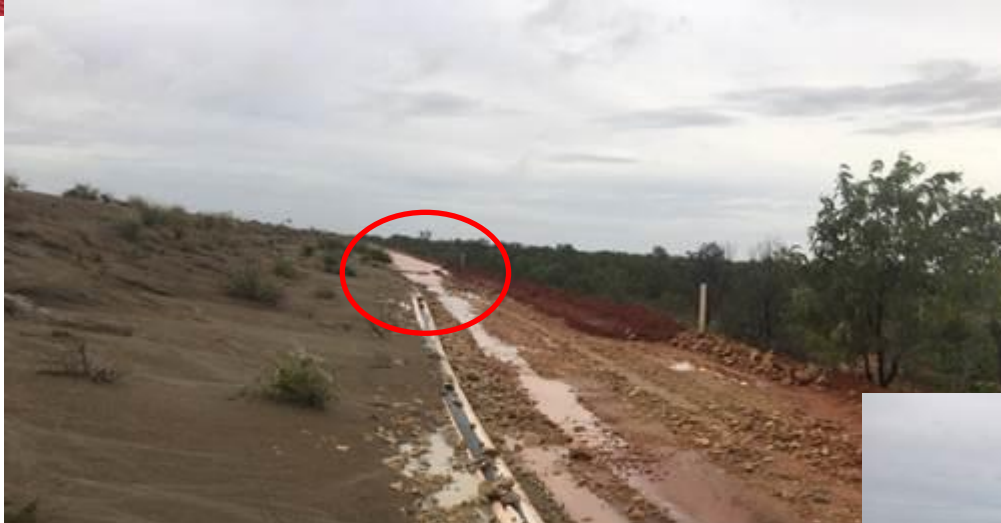
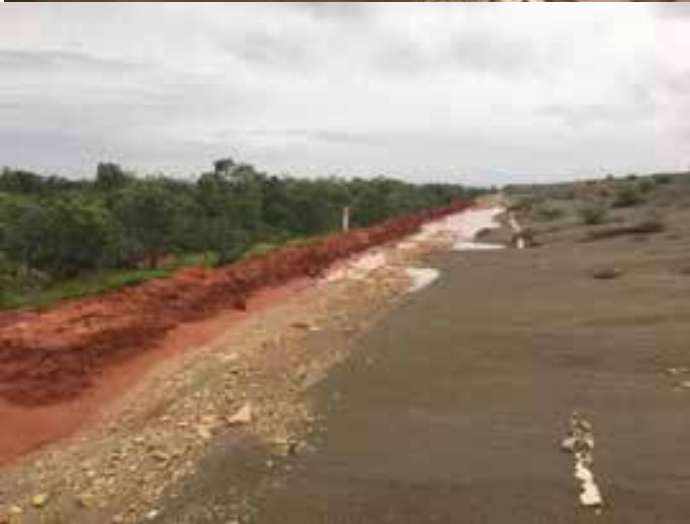
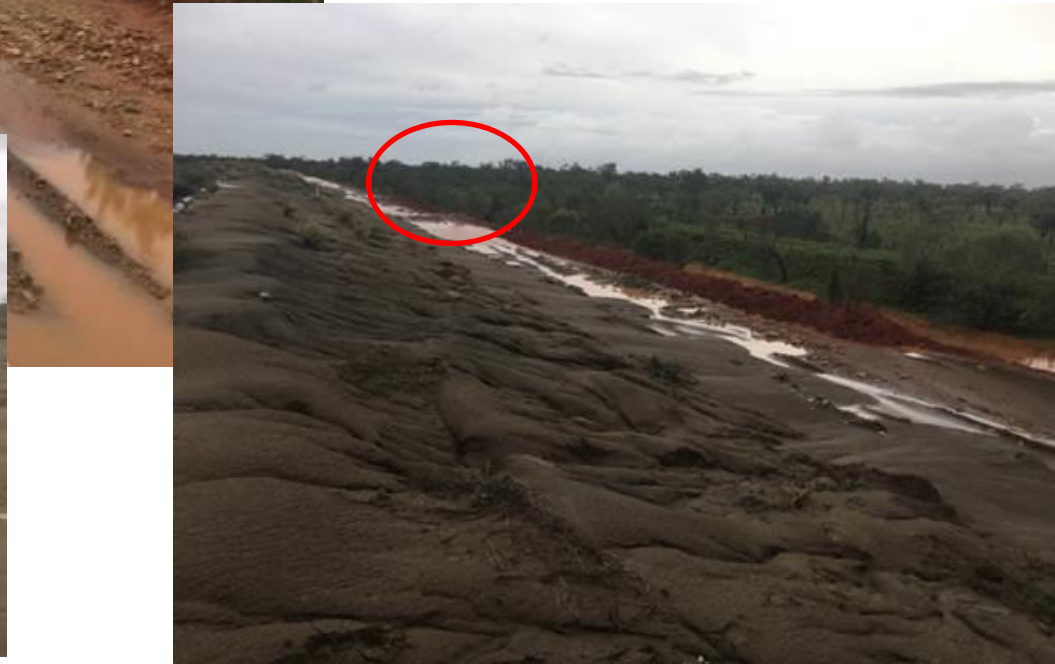
Ellendale...and then it rained and rained

Cyclone Yvonne - 250mm in 48hrs
2 weeks after works were completed

Wettest wet season on record

Assess how TSF stood up in Q3 2017
