AUCKLAND HARBOUR BRIDGE

MEETING ENVIRONMENTAL CHALLENGES SUSTAINABLY

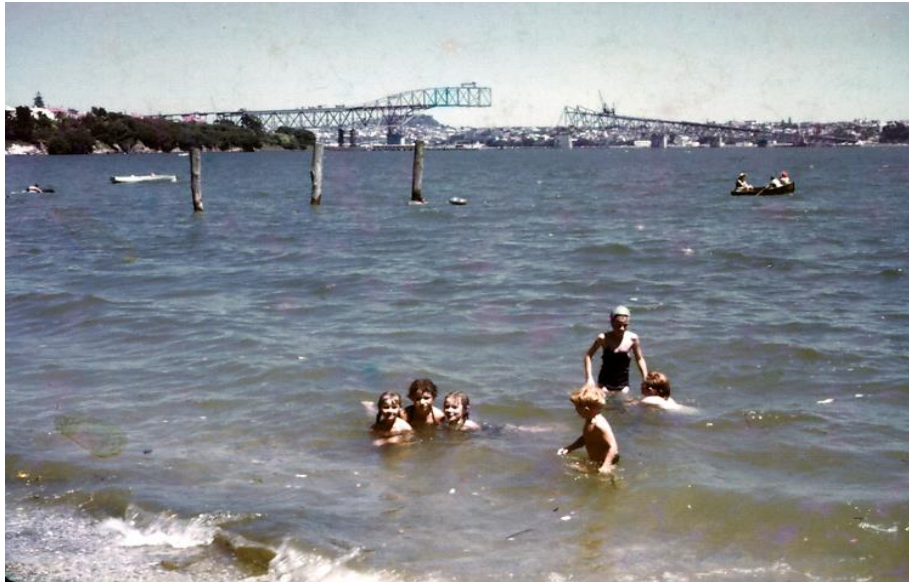
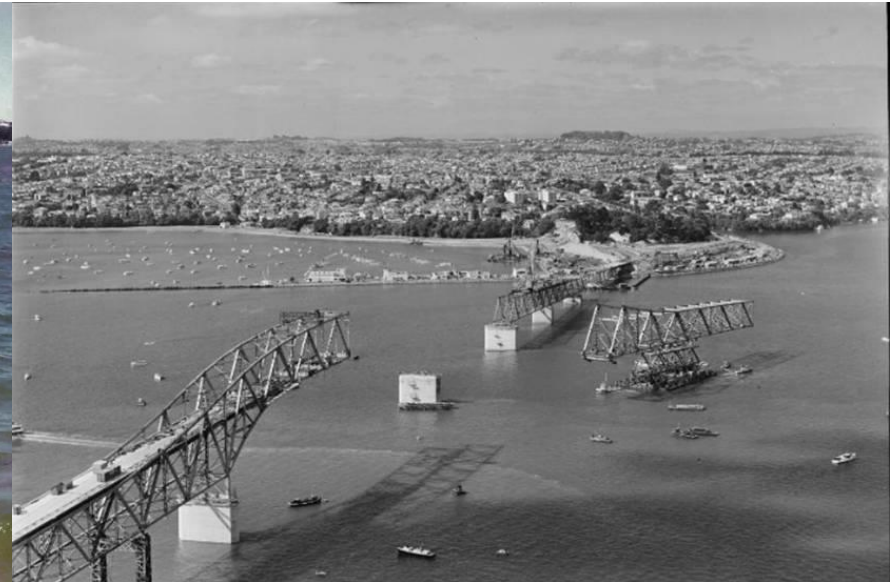
History

- Opened May 1959
- Widened 1969 – ‘clip-ons’

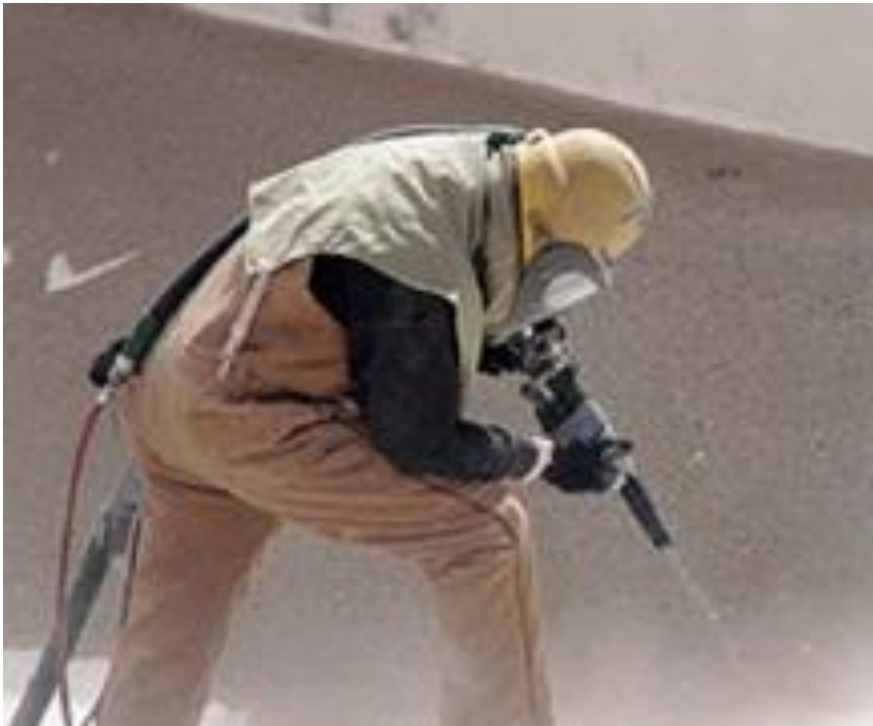
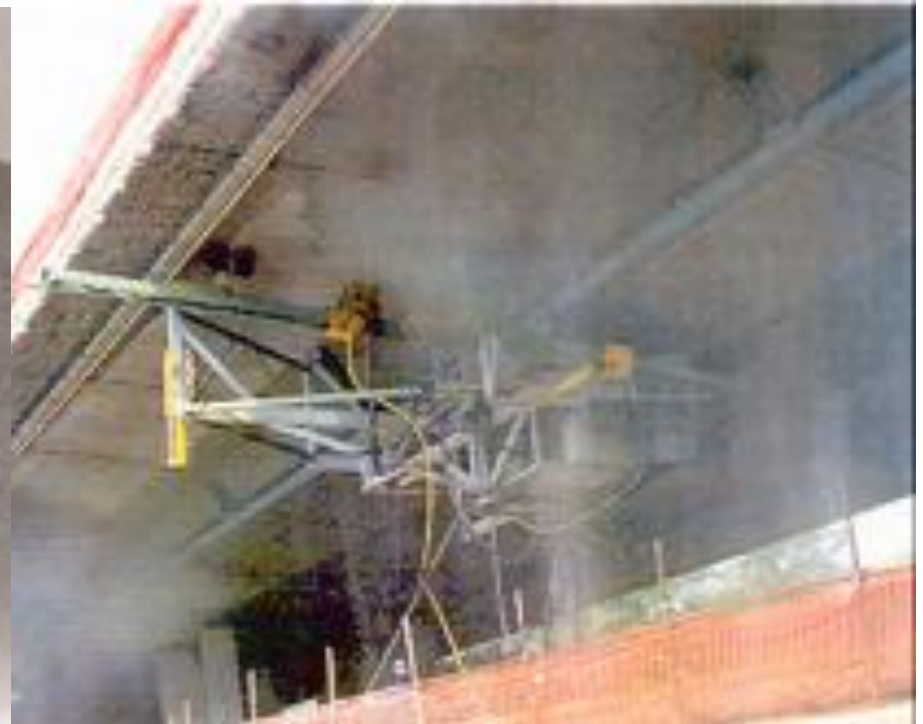
Maintenance Activities

Surface Preparation

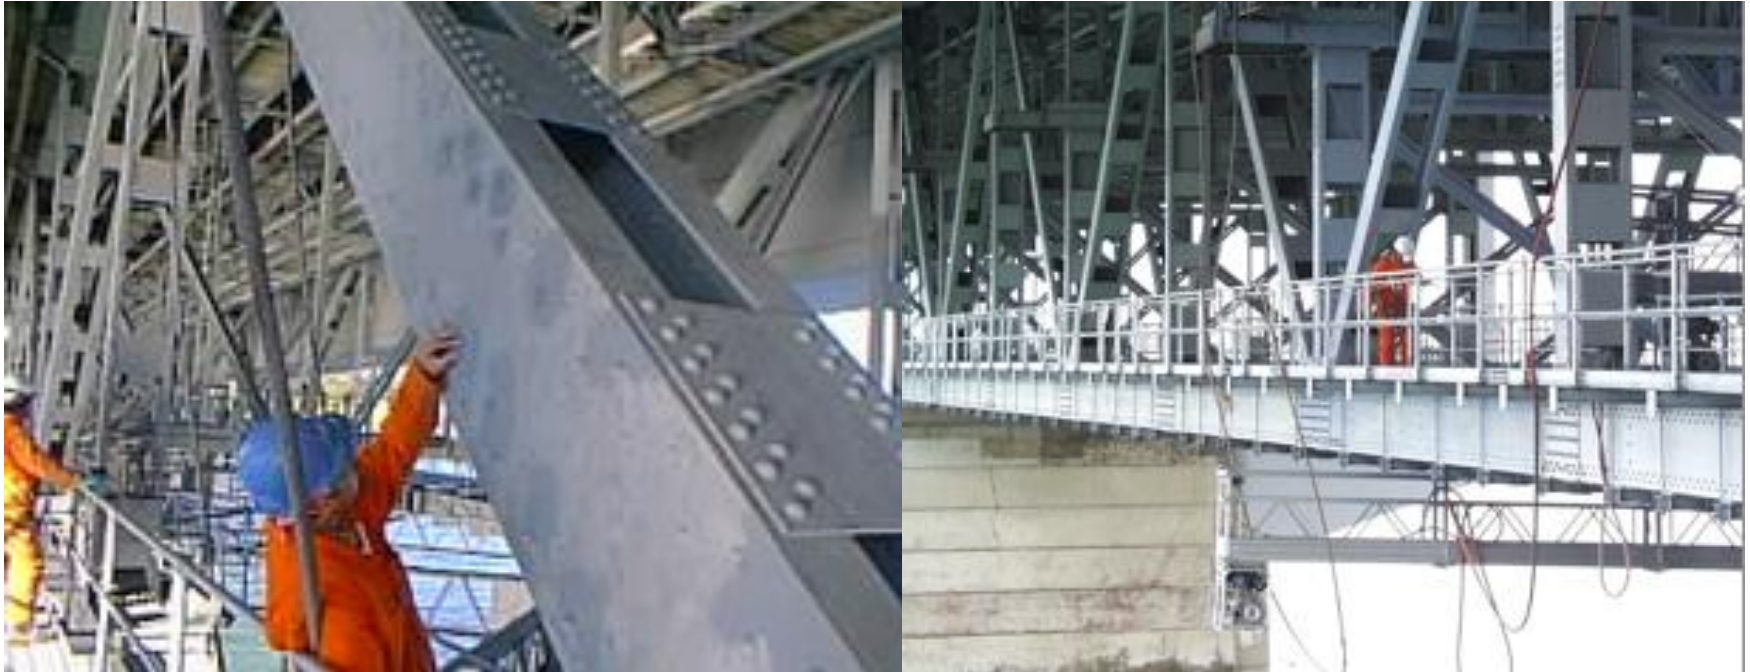
Maintenance Activities

Recoating

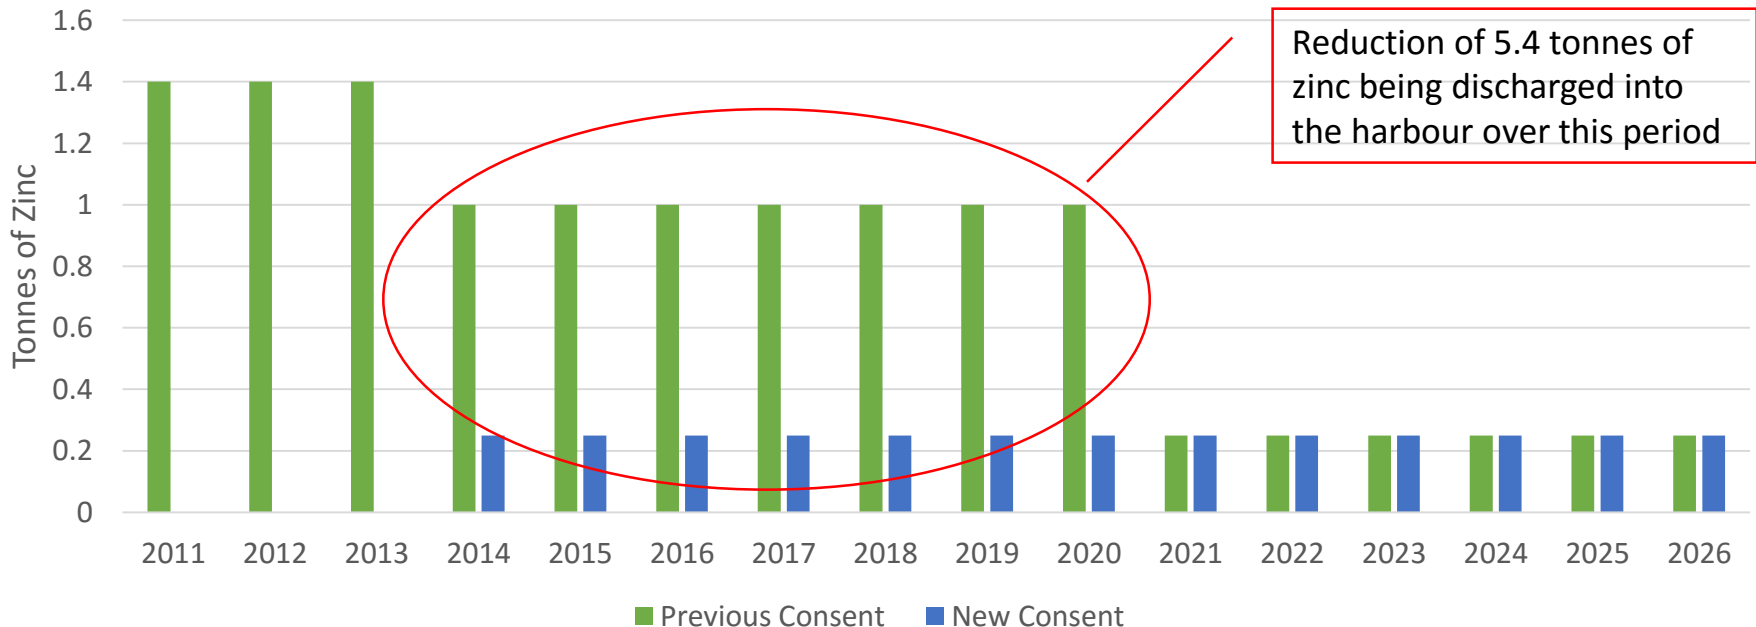
Reducing Zinc Inputs to the Waitemata Harbour

Zinc Discharges Authorised by Maintenance Consents
