# Western Belfast Bypass

– Aquatic ecology aspects & sharing of lessons learnt

- State Highway 1
- Location: Belfast, Christchurch
- Start date: May 2015
- Finish date: Nov 2017
- Client: NZTA
- Client Engineers: Opus
- Contractor: Fulton Hogan
- Aquatic Ecologist: Boffa Miskell
- Contract type: Construction only
- Works: A new 4-lane, 5km long, median divided motorway
- Extends the Christchurch Northern Motorway (SH1) to link with Johns Road (SH1), Christchurch.

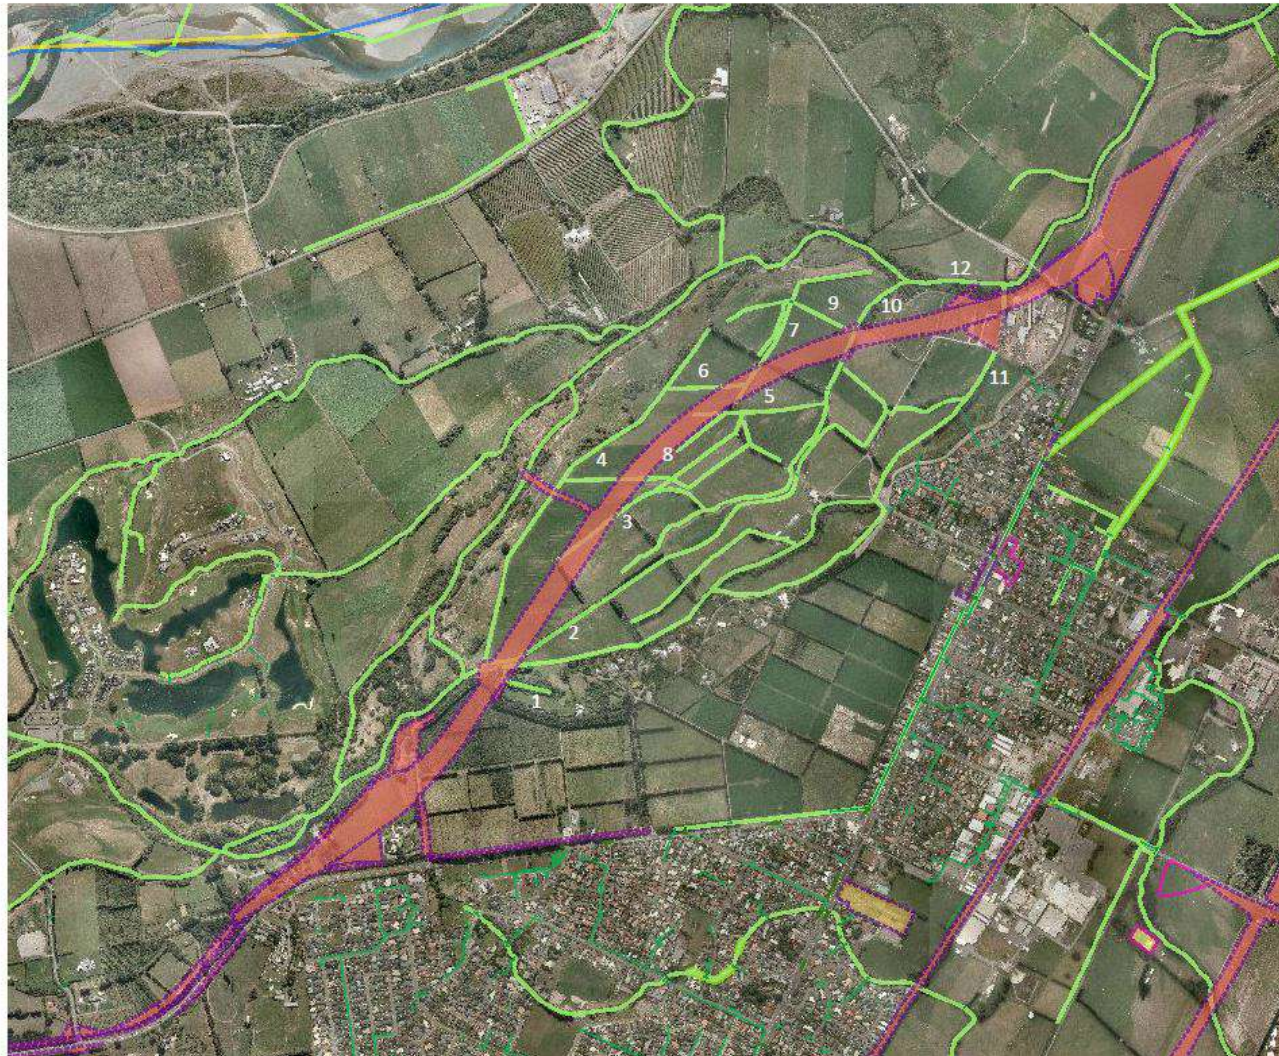
Western Belfast Bypass—Streams and Drains

1. Darroch St Drain
2. Griffin Drain
3. Kingsbury Drain
4. Jeffs Drain
5. Whitmore Drain
6. Rapley Diversion
7. Bayfield Drain
8. Frankish Drain
9. Bourne Drain
10. Horrell Drain
11. Darroch St Drain
12. Otukaikino Stream

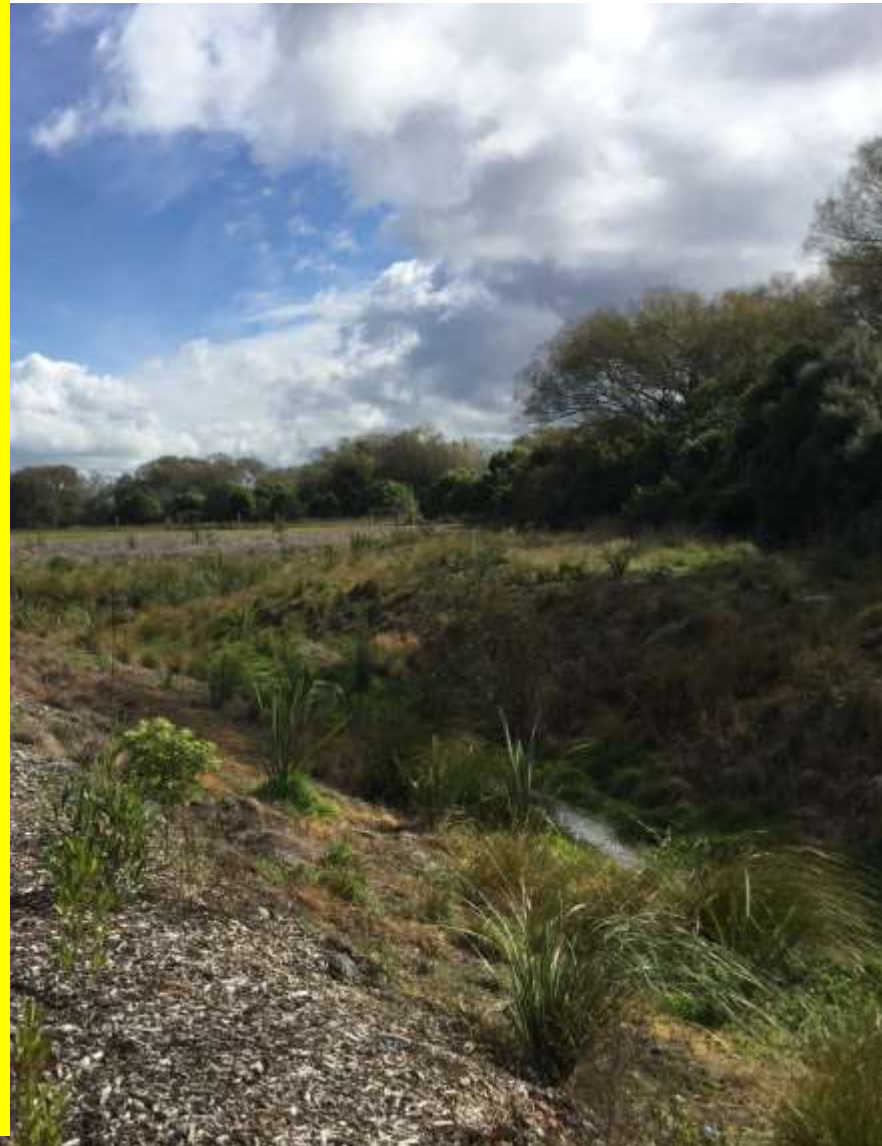
As many fish will be removed as possible from the affected waterways prior to dewatering and diversion.

Barriers will be placed within the channels at the upstream (where applicable) and downstream ends of the waterways to prevent fish recolonising the channel once it has been fished out.

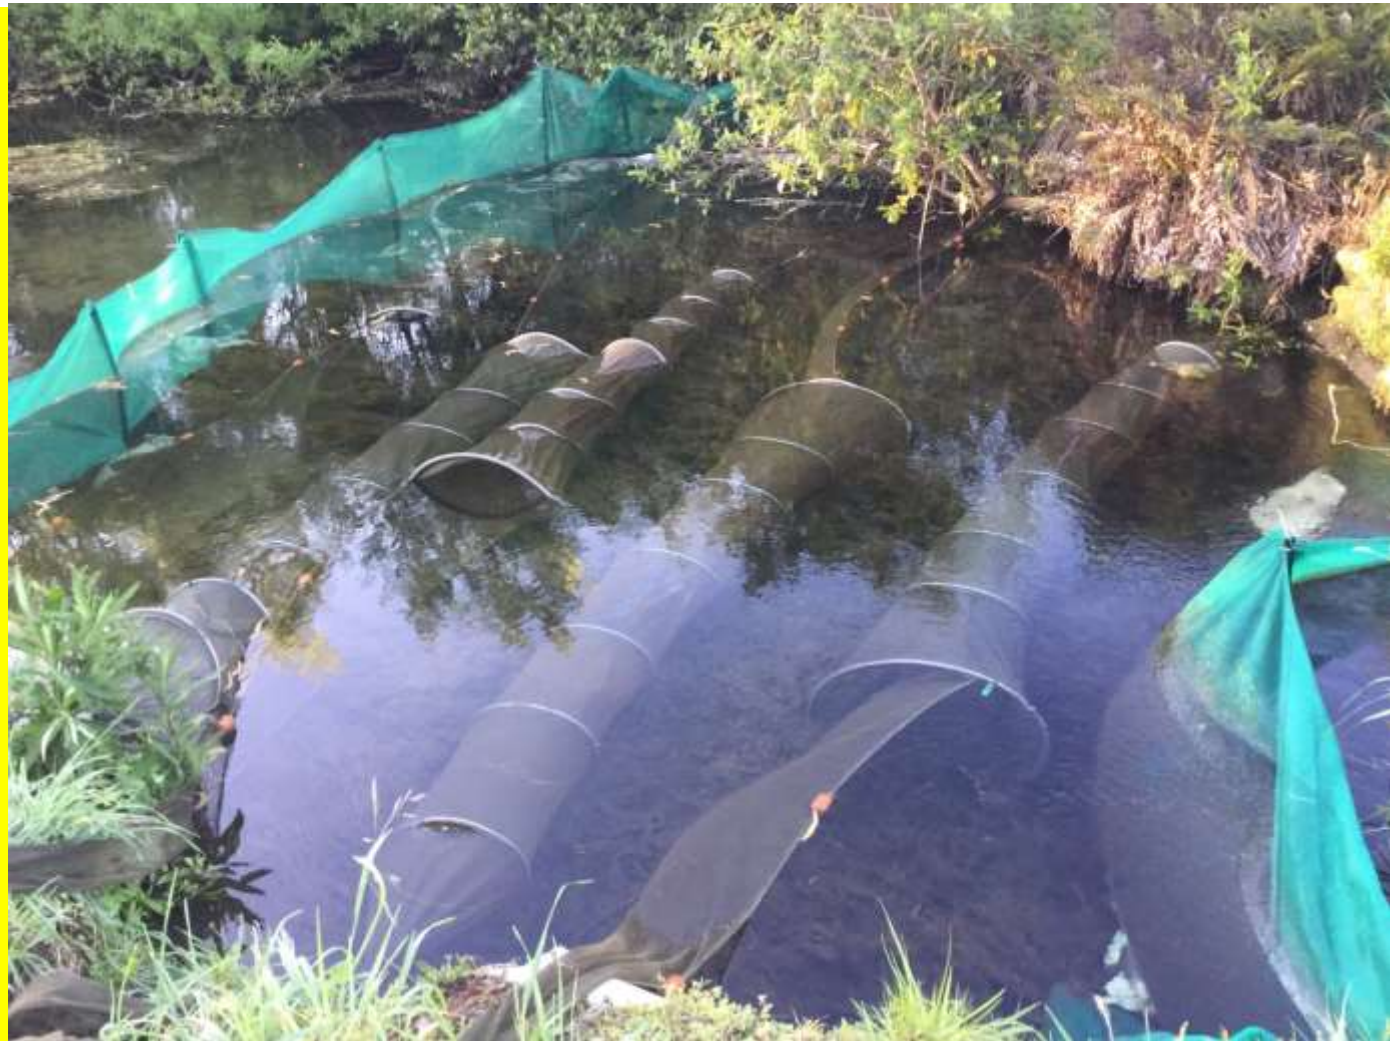
## Mitigation options:

- Ensure appropriate treatment of the discharge prior to discharge
- Minimise erosion and scour at the discharge point(s)
- Utilise the existing CCC stormwater network
- Ensure an appropriate mixing zone in the water body
- Ensure the discharge does not have a detrimental impact on flora and fauna downstream of the discharge point; and
- **Minimise the volume of dewatering water discharged to surface water bodies through reuse and land-based detention and soakage.**

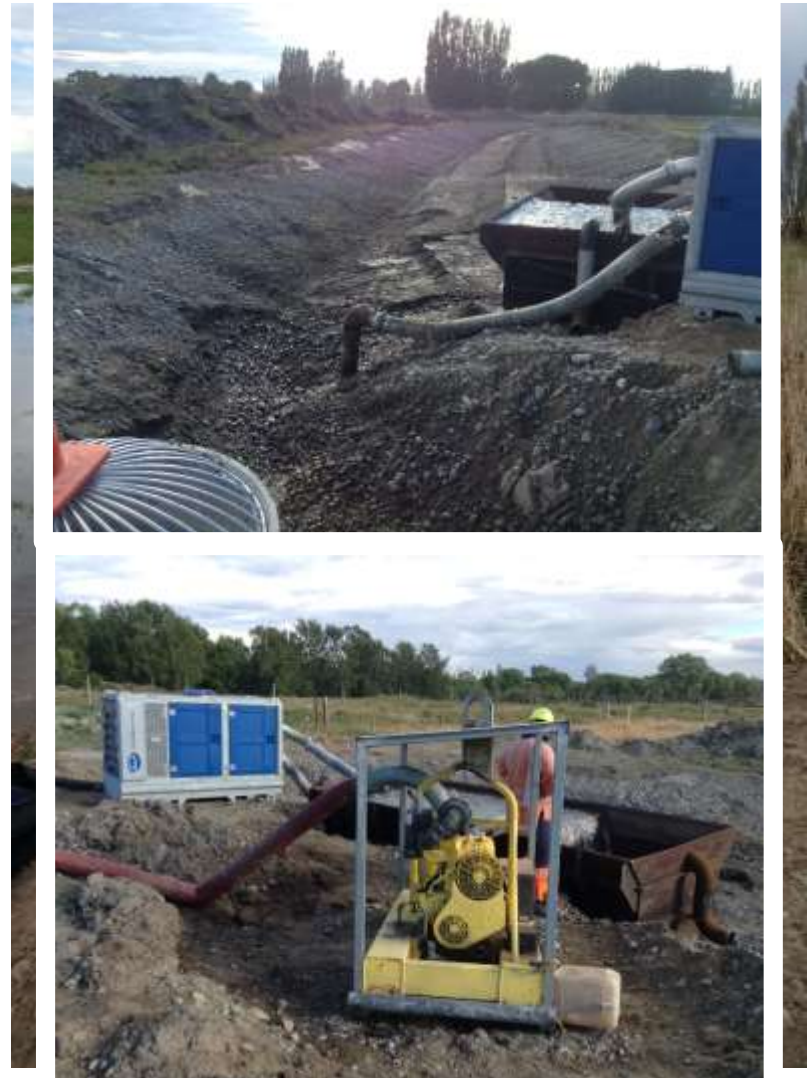
Fish passage to be maintained during construction

Temporary diversions to be inspected by a qualified ecologist at regular intervals

2 hourly monitoring for all dewatering activities whilst works are taking place.

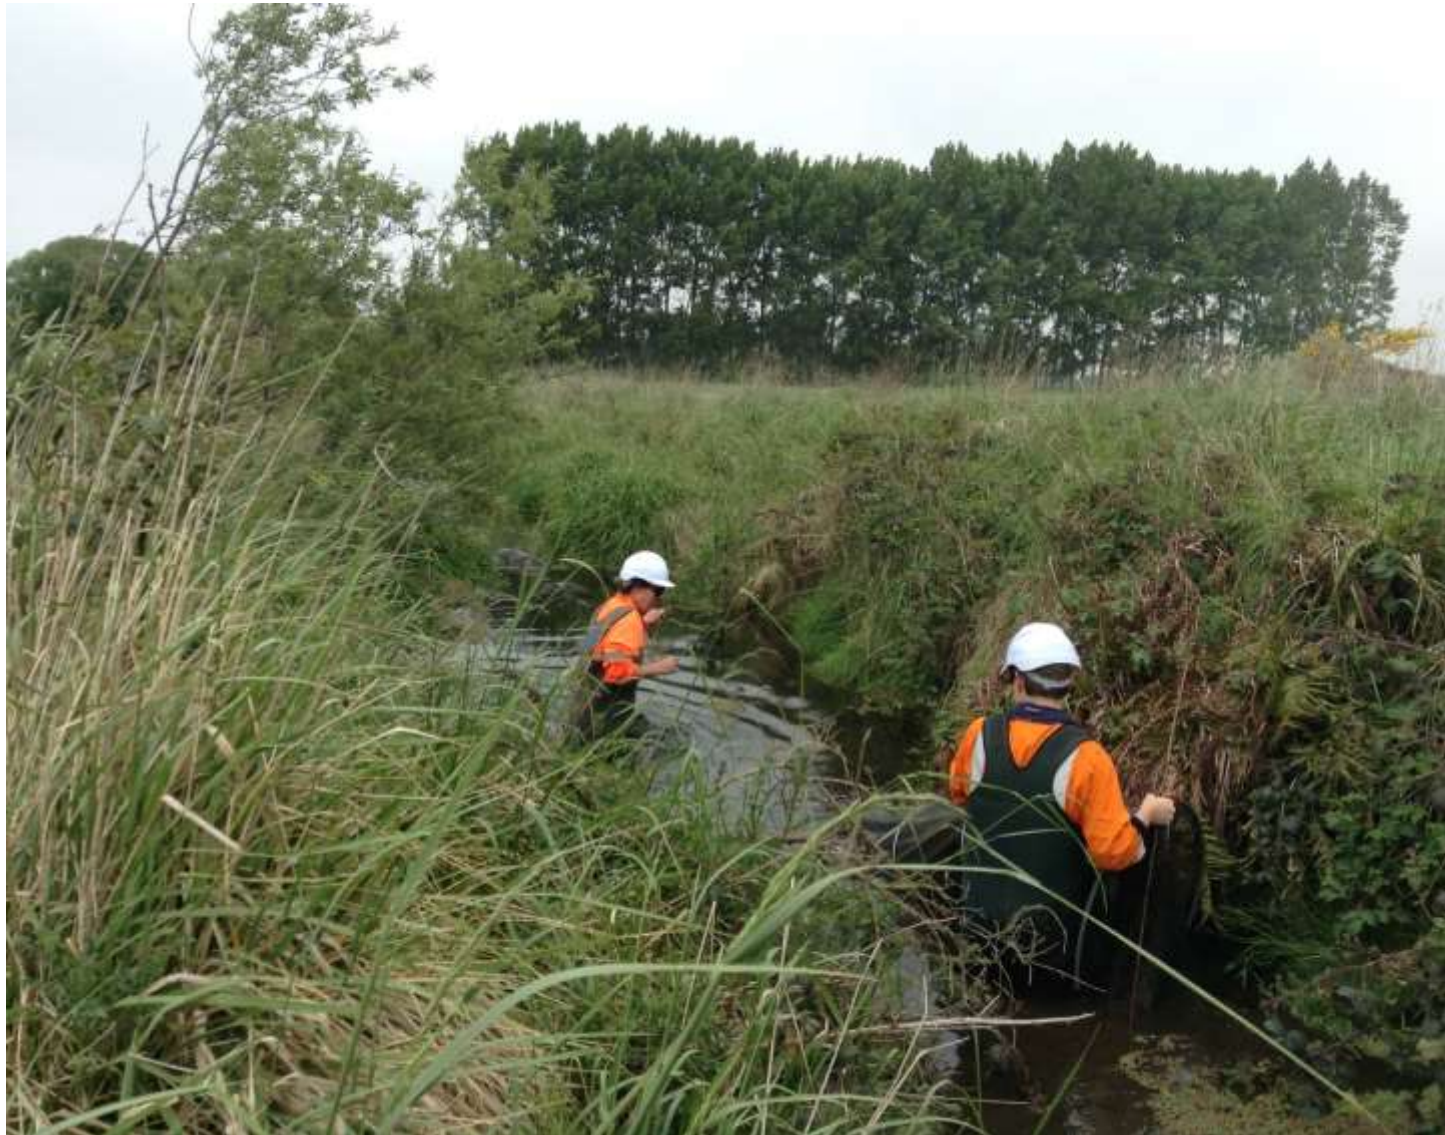
Constructed channels will need to present habitat of equal or better quality than the channels they have replaced.

Monitoring should occur 6 months after channel commissioning and may continue on an annual basis for four years.

Results to be compared to the pre-construction assessment completed in 2012.

If results indicate a habitat of less value, steps should be taken to improve the value.

Overall, the post-construction monitoring indicates the ecological health of the constructed channels of Kingsbury and Horrell Drains is at least the same as pre-construction, baseline conditions.

The freshwater fish community found in both Kingsbury and Horrell Drain was more diverse in the constructed channels than found during the baseline survey.

In-fill planting of taller stature species recommended to increase canopy cover and stream shading in the future.

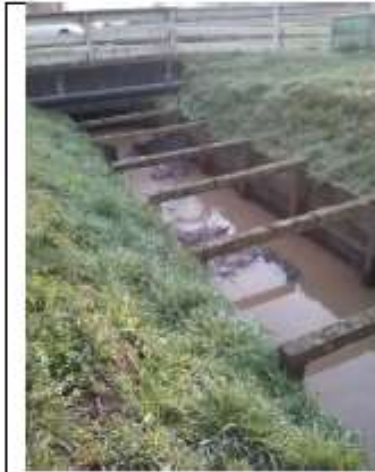
A fish screen that was blown out in a storm. Area had to be re-fished.

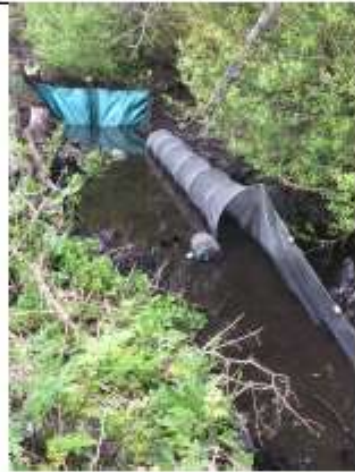
Silt fence used as a fish screen in stagnant water. Is this idea?

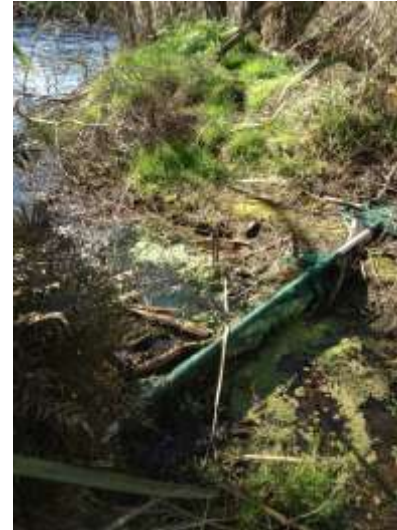
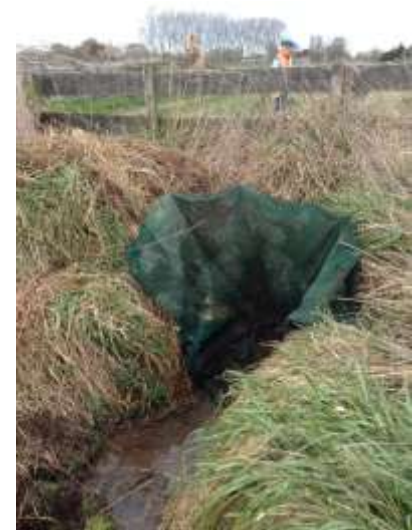
Silt fence used as a fish screen. Is this idea?

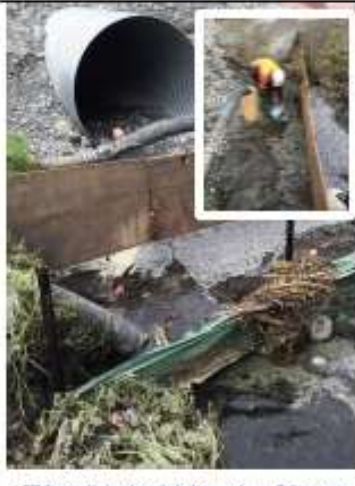
Silt fence, timber boards being used as a fish screen. Inset – Subcontractor salvaging silt from within the isolated work area.

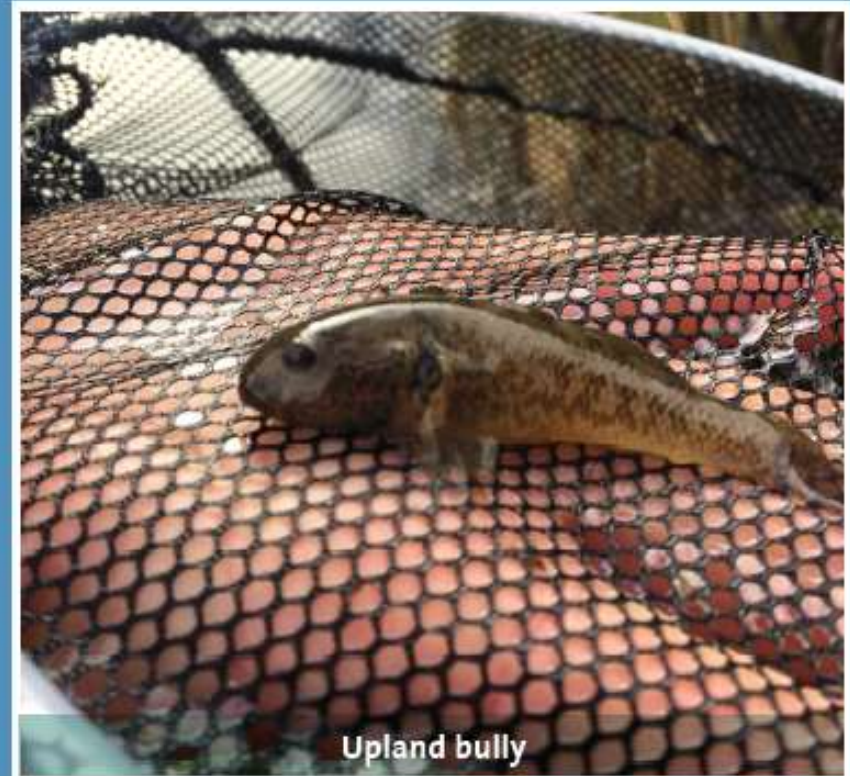
Upland bully
